11. TITLE (Include Security Classification) <b>Repair of Dam Intake Structures and Conduits: Case Histories</b>					
12. PERSONAL AUTHOR(S) <b>Campbell, Roy L., Sr., and Bean, Dennis L.</b>					
13a. TYPE OF REPORT <b>Final report</b>		13b. TIME COVERED FROM _____ TO _____		14. DATE OF REPORT (Year, Month, Day) <b>January 1988</b>

19. ABSTRACT (Continue on reverse if necessary and identify by block number)					
<p>Based on a survey of inspection reports, 29 percent of the maintenance and repair problems at Corps dams were observed in intake structures and conduits. Repairs to these structures did not perform as desired in better than 40 percent of the reported efforts and with better than 21 percent reported as failed. A number of products whose manufacturer's literature indicated that their products were suited for application in a wet environment such as that found in intake structures and conduits failed. In some instances, the repair technique was at fault. In others, the product failed to perform as indicated.</p> <p>This report documents selected repair efforts to intake structures and conduits and presents them in a case history format that includes a project description an

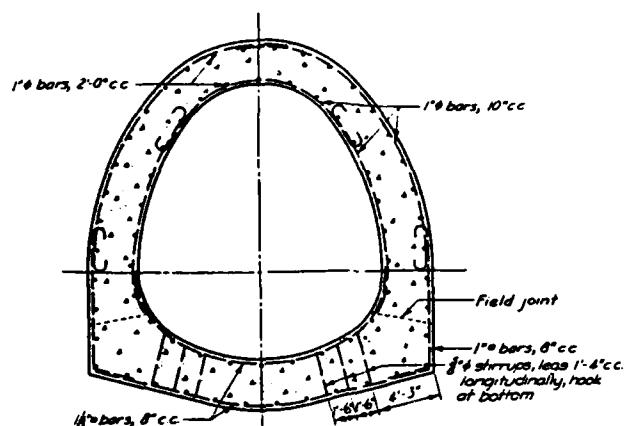
Figure 1. Typical conduit section, Arkabutla Dam

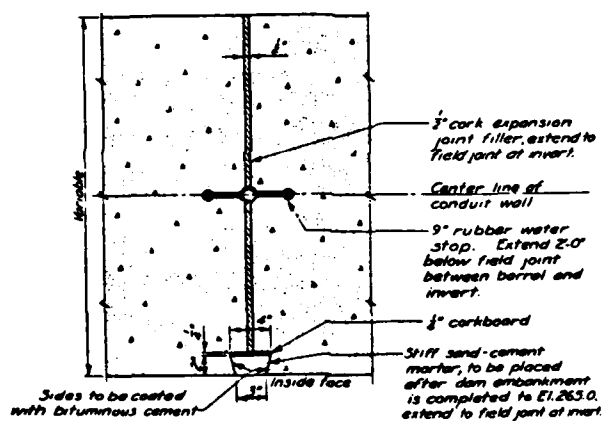
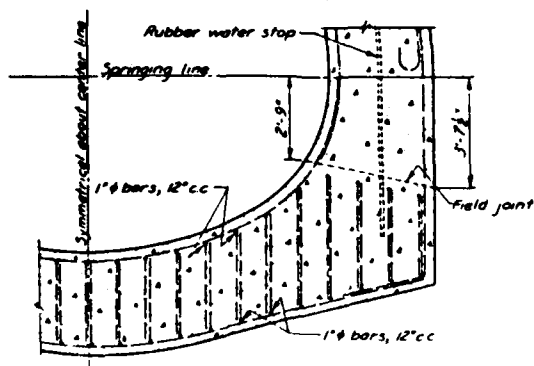
10. It appears that the omission of water stops in the invert is the major contributing factor in the leakage and associated deficiencies observed at the monolith joints of the conduit. During the early operations of the outlet works, leakage was observed at the upstream joints between monoliths 1 and 7. Leakage continued after remedial grouting in 1950 and was accompanied by loss of foundation material and differential movement. Movements of 0.04 ft or greater were reported in 1969 for monolith joints 3/4, 6/7, 9/10, and 10/11. Also reported were spalling and missing filler at various joint locations. Remedial grouting of all conduit joints was performed in 1970. In 1974, a sinkhole developed in the embankment above the downstream end of the conduit near the west edge of the toe road. This sinkhole was cleaned out and backfilled with sandy clay after an investigation concluded that the sinkhole had developed from earlier foundation material losses through openings which were grouted in 1970. Leakage continued and remedial grouting was performed in 1977. In total, leakage has occurred to varying degrees at all monoliths

Figure 2. Waterstop location in joint, Arkabutla Dam

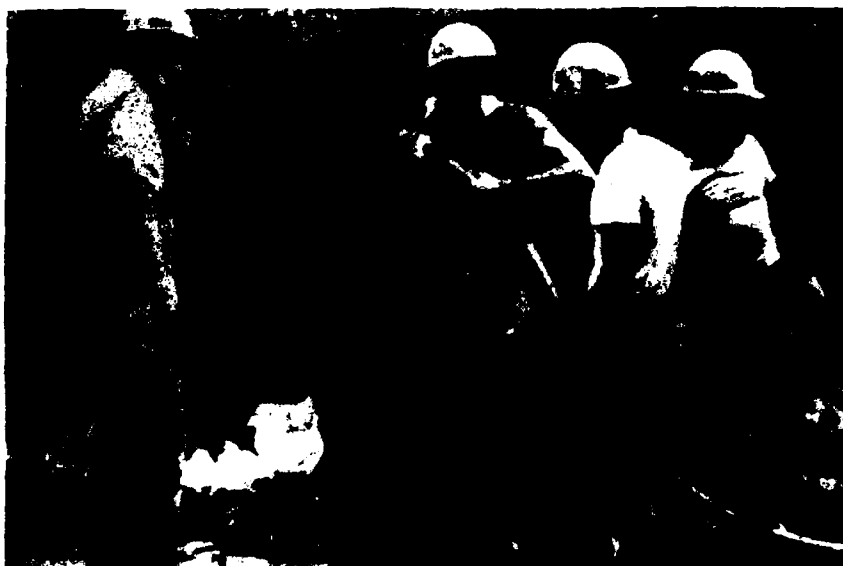
Figure 11. Grouting using standpipe, Arkabutla Dam, 1977

24. At the end of the grouting day, all grouted holes were inspected. Water dripping from a hole when the valve was slightly opened indicated grout had not sealed the leak. A 4-ft-tall standpipe was connected to the hole and filled with 1:1 grout (Figure 11). If water was observed dripping from the top of the standpipe the next day, adjacent ports were cleaned out, jetted with water, and then pressure grouted with a 1:1 mix.

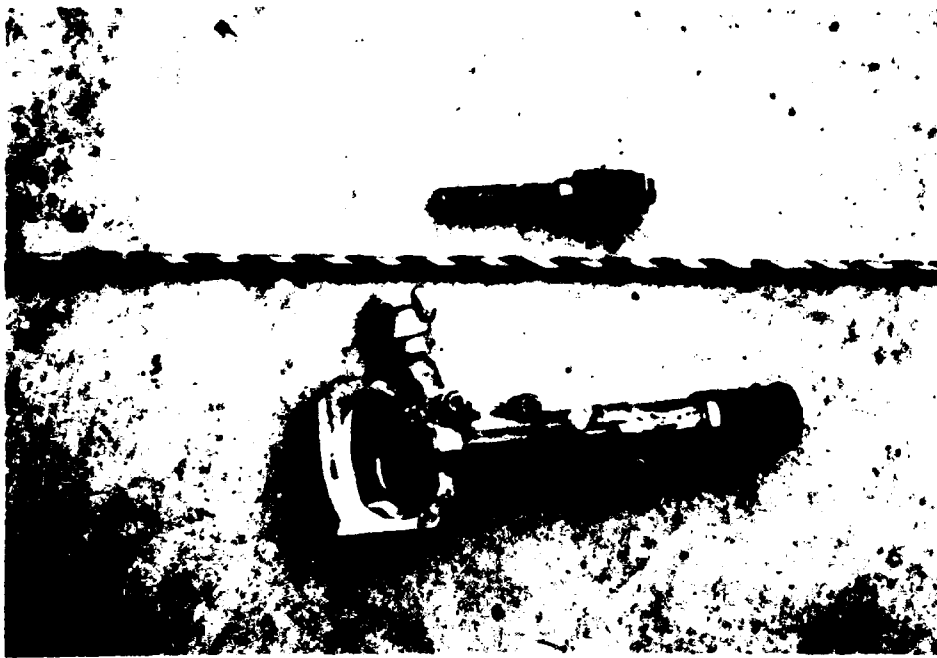
Figure 14. Rotary hammer drill, adapter, and bit, Blakely Mountain Dam, 1986

Five hundred and fifty feet of hose was used to supply air to monolith joint 20/21 where the drilling was started. Two Chicago pneumatic rotary hammer drills, model number 9A, were used to drill the grout holes. The grout holes were 5/8 in. in diameter and were drilled using 18 and 36-in.-long masonry bits that were carbide tipped and had SDS (SR) series shanks (Figure 14).

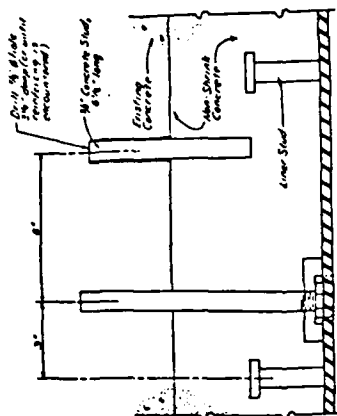
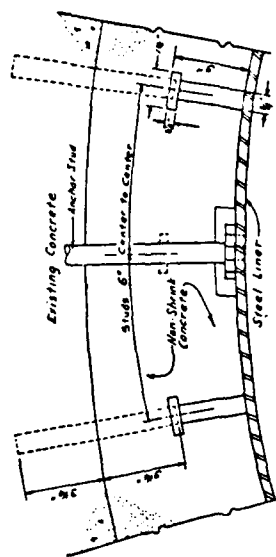
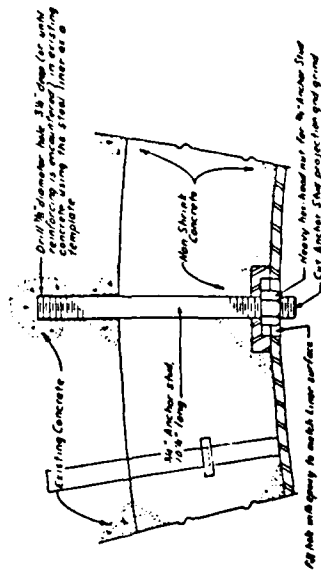
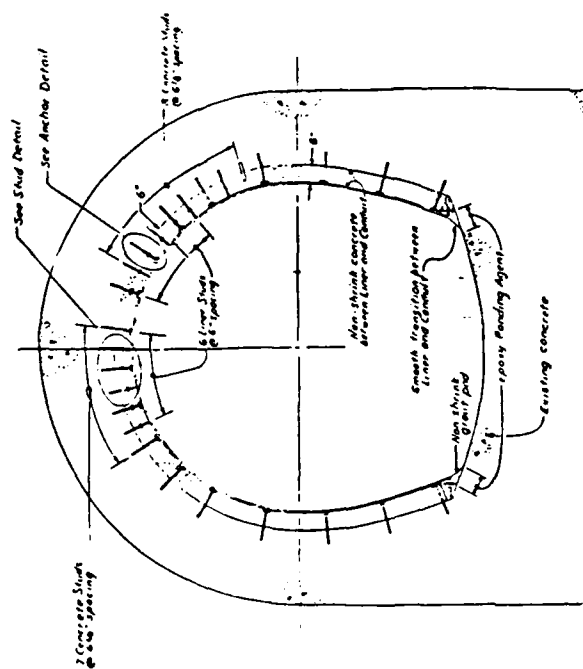
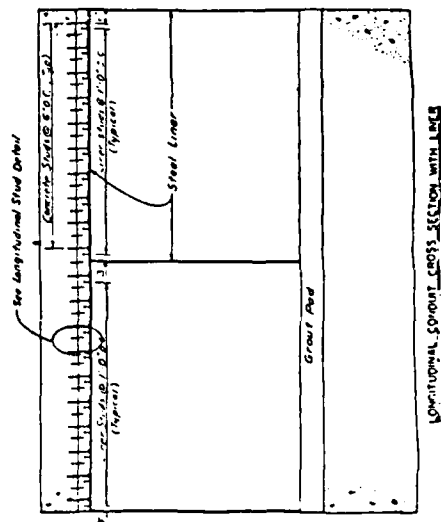
Figure 31. Anchor details for steel liner and nonshrink concrete fill, Eau Galle Dam

120. The composite liner (Figure 31) consisted of a 3/8-in.-thick steel-plate liner and a 5-5/8-in.-thick layer of nonshrink concrete pumped between the steel and the existing concrete. Steel studs 3/4 in. in diameter (Figure 31) were used to tie the existing concrete, nonshrink concrete, and steel plate together to form a composite structure. The end sections of the repair, monoliths 8 and 24 (Figure 32), consisted of a tapered composite liner of nonshrink concrete and epoxy grout abutted at its end with an epoxy grout liner. The tapered composite liner was integrated with the existing concrete by a ring of dowels located in the nonshrink concrete 2 ft from the joint at the end of the concrete-steel liner and by epoxy bonding agent at the interface.

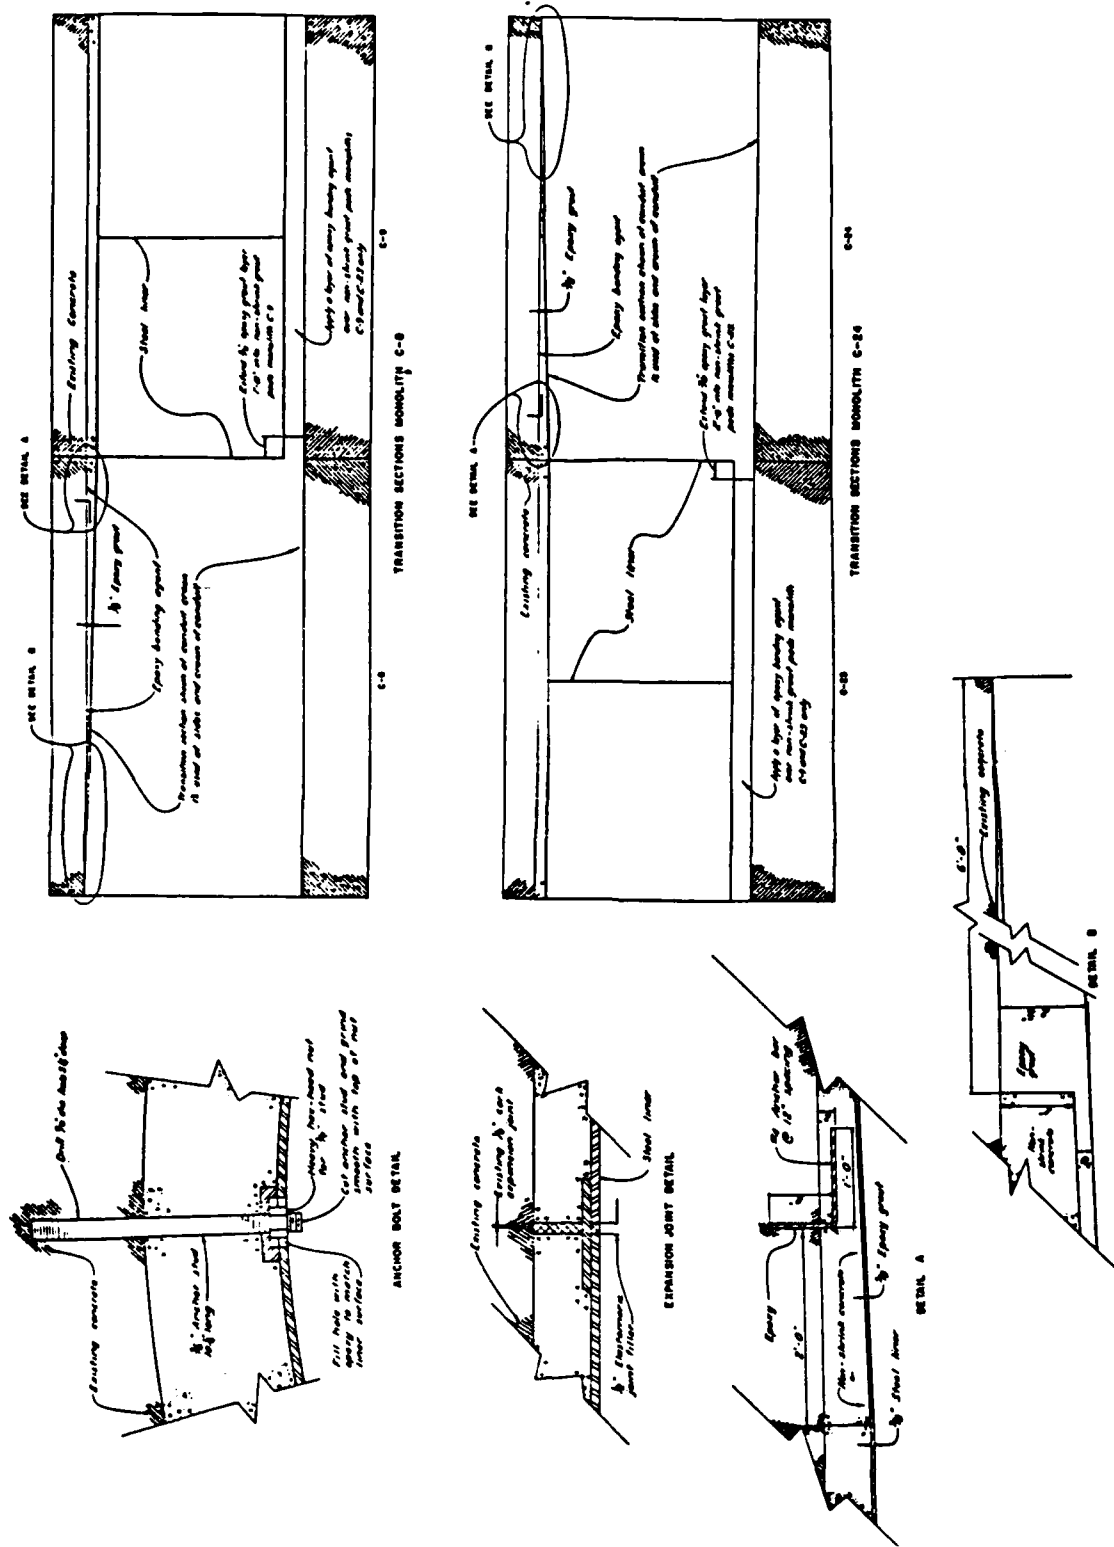
Figure 32. Details for transition sections of repair, Eau Galle Dam

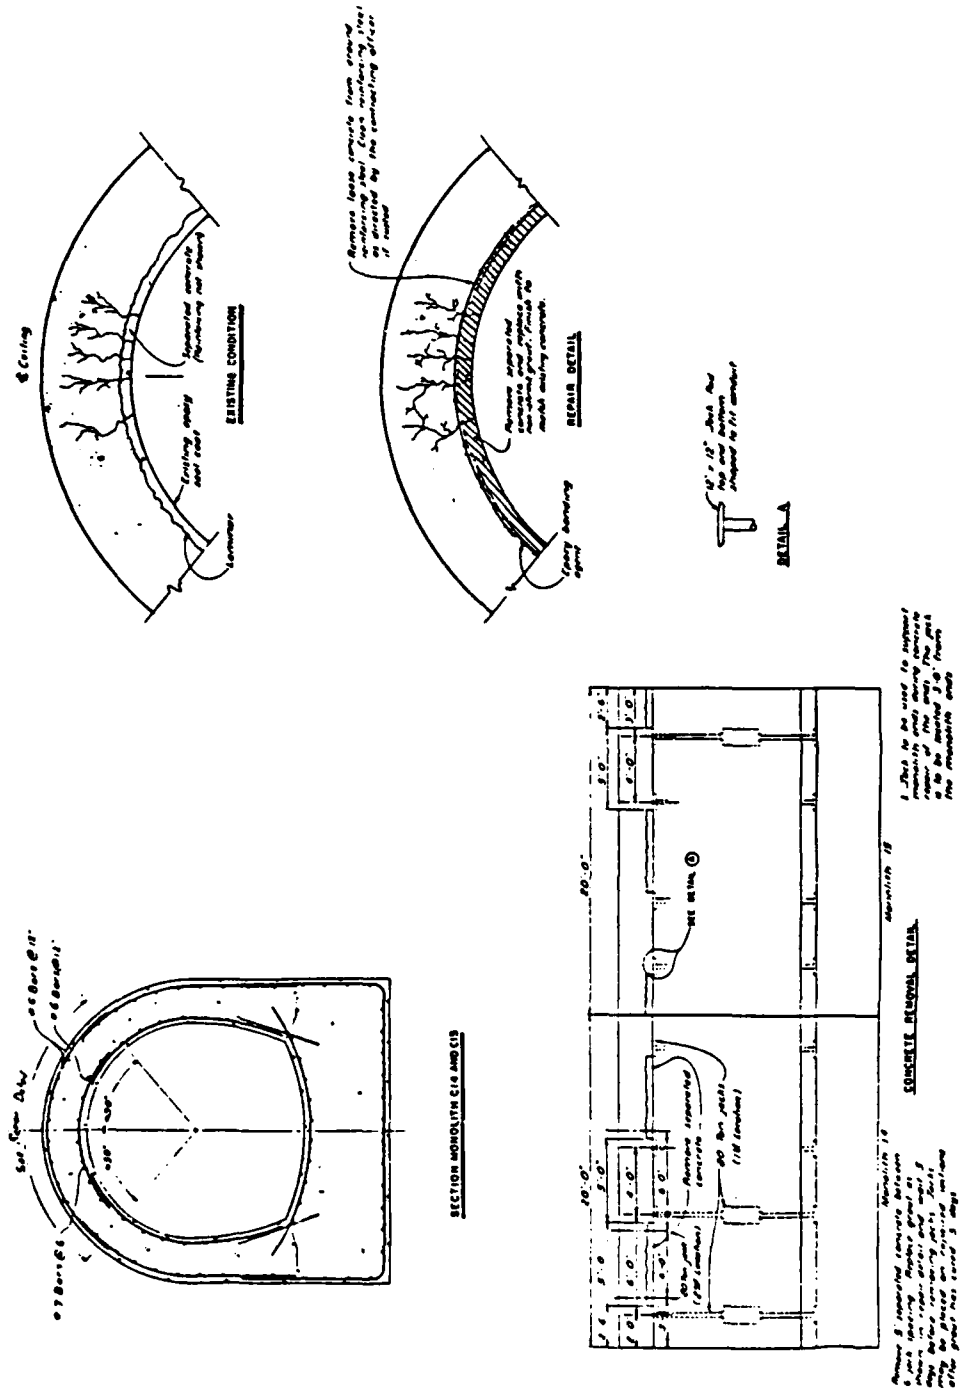
Figure 33. Details of removal and replacement concrete in crown of conduit, Eau Galle Dam

122. In a few of the monoliths containing the most severely delaminated concrete, the damaged concrete in the crown of the conduit was removed and

replaced with a nonshrink grout prior to installation of the steel liner (Figure 33). The work was performed in reaches of 5 ft and required 80-ton jacks at the ends of each reach to support the ceiling during the repair. The specifications for the nonshrink grout required aluminum powder as expansive agent, No. 4 maximum size aggregate, Type III portland cement, and minimum compressive strength of 4,200 psi.

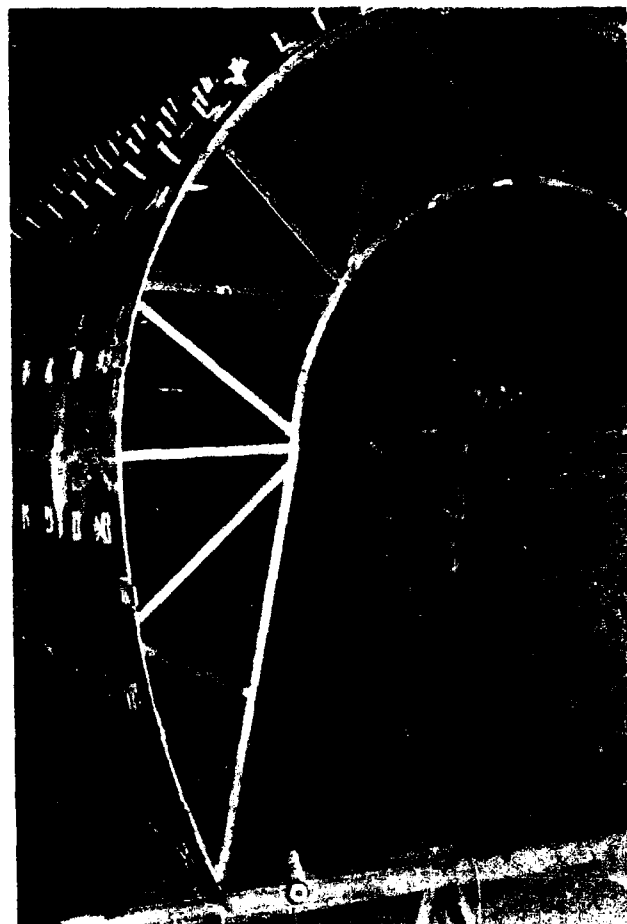
Figure 34. Steel plate liner, Eau Galle Dam

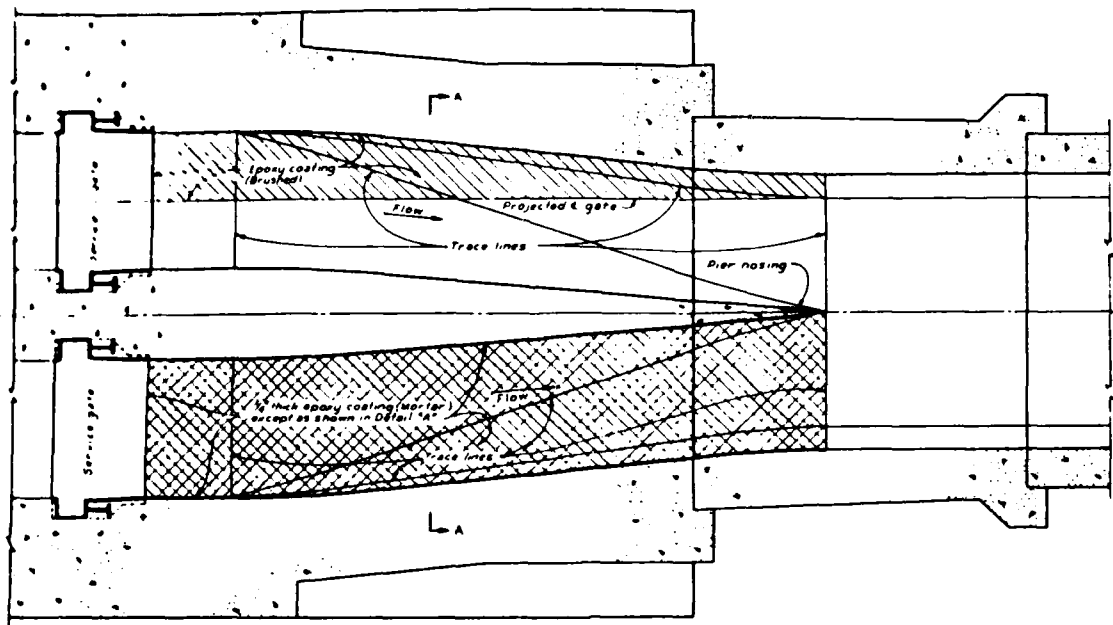
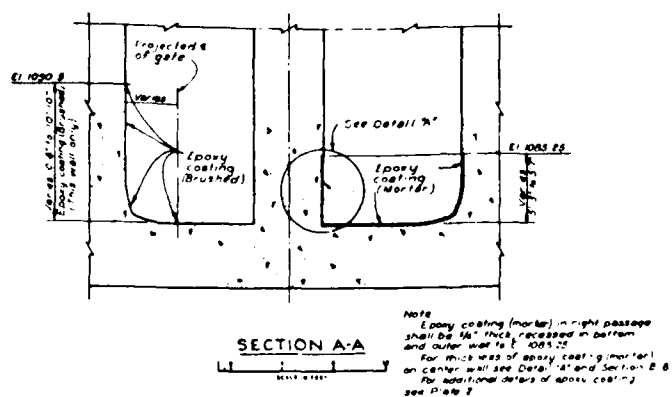
174. In the left gate passage, the brush-on epoxy was applied to the wall and floor left of the passage centerline (Figure 43). The epoxy was not applied to the right half of the passage to provide a base from which the effectiveness of the coating could be evaluated.

Figure 43. Locations of applied coatings, Milford Dam

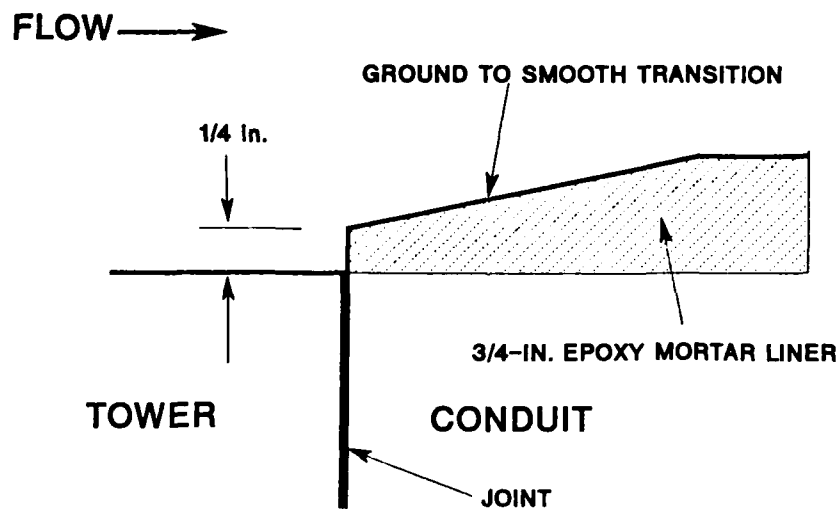
194. The remaining epoxy liner in the right passage invert was saw-cut at the junction for walls and invert along the length of the passage and removed in an effort to prevent the delamination and mortar loss from extending into the liner of the wall. The mortar liner at the upstream edge of conduit monolith 1 was ground to within 1/4 in. of the adjoining upstream surface that had lost its mortar (Figure 46). This was done to provide a smooth surface transition, thereby, eliminating a condition that could result in turbulent flows and cavitation damage.

Figure 46. Edge ground to provide smooth transition at monolith joint, Milford Dam

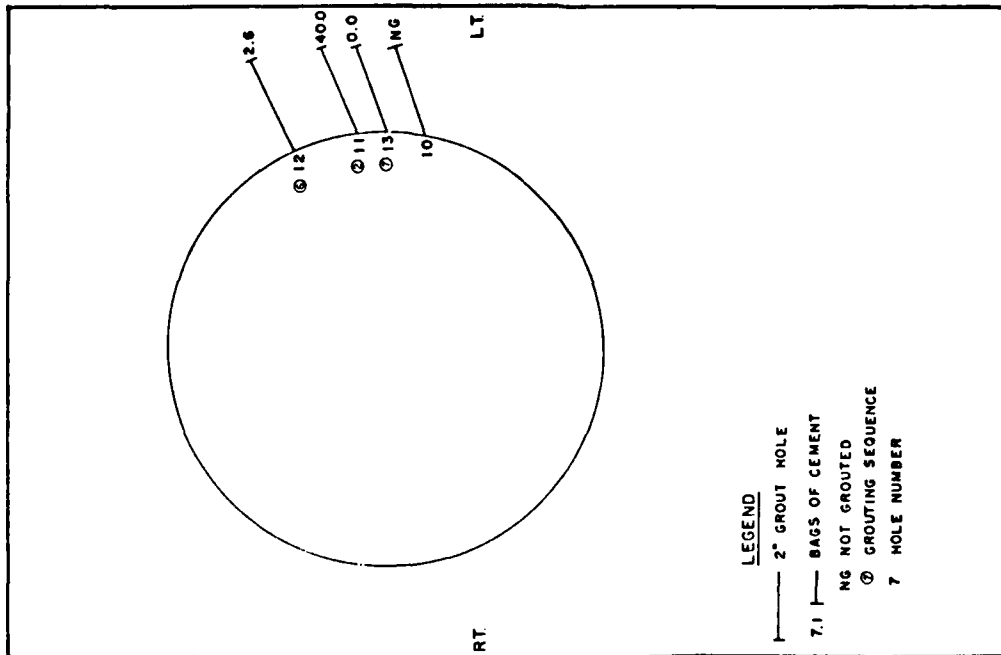
206. Four holes were drilled near the left spring line at monolith joint 2/3; three of the holes were grouted with 42.6 sacks of cement or 53.25 cu ft of grout. Nine holes were drilled around the joint 8/9, with the majority drilled on the upstream side; four of the holes were grouted with 90.7 sacks of cement or 119.85 cu ft of grout. Figures 48 and 49 show drill hole locations, grout takes, and grouting sequence for joints 2/3 and 8/9.

Figure 48. Details of grouting for joint 2/3,  
Pine Creek Dam, 1976

209. 1976. Remedial grouting (USAED, Tulsa 1976) using a portland-cement (Type II) grout was performed in July 1976 by district personnel to stop continuing leakage at monolith joints 2/3 and 8/9 and new leakage at joints 5/6, 12/13, and 13/14. Approximately eight holes were drilled around the periphery of each joint using air drills and 1-7/8-in.-diameter diamond bits. If contact was made with the leaking joint before the conduit wall was penetrated, drilling was stopped and the hole grouted. Usually several holes were drilled before grouting began. Prior to grouting, all holes were pressure tested using the maximum grouting pressure. Holes that would not take water were not grouted. The grout was injected through a packer set in the top of the hole. Mixtures with a water-cement ratio ranging from 4:1 and 0.75:1 by volume were used. The majority of the holes were grouted with a 1:1 mixture. Grouting pressures ranged from 15 to 30 psi. To prevent grout leakage, the joints were caulked with lead wool. All holes were backfilled or packed with cement. A total of 127.8 sacks of cement or 250.5 cu ft of grout were used in grouting the leaks. The total cost of the repair was estimated to be \$25,000.

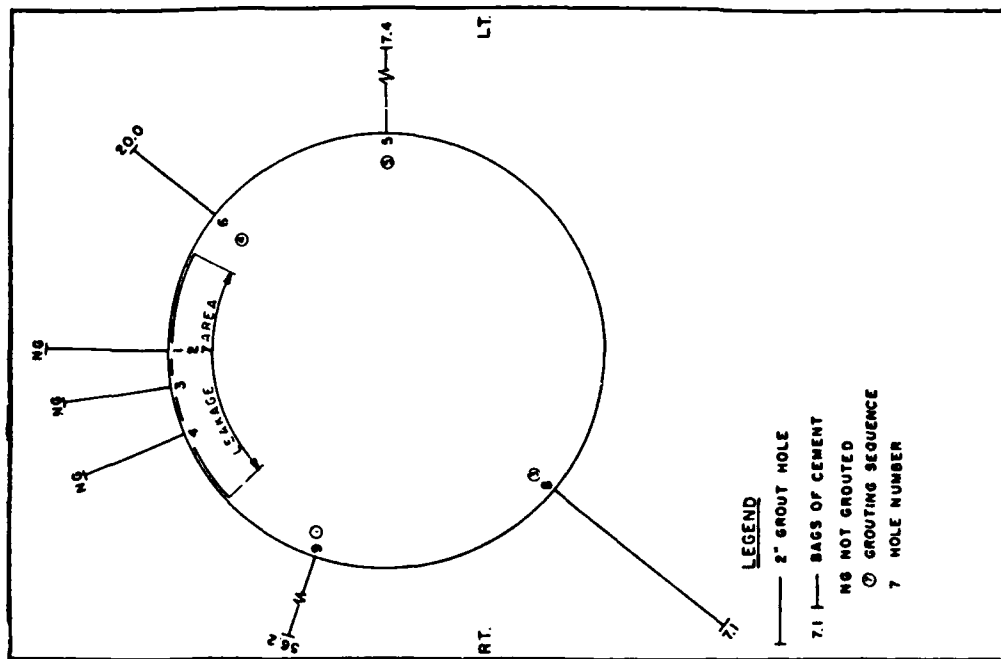
Figure 49. Details of grouting for joint 8/9,  
Pine Creek Dam, 1976

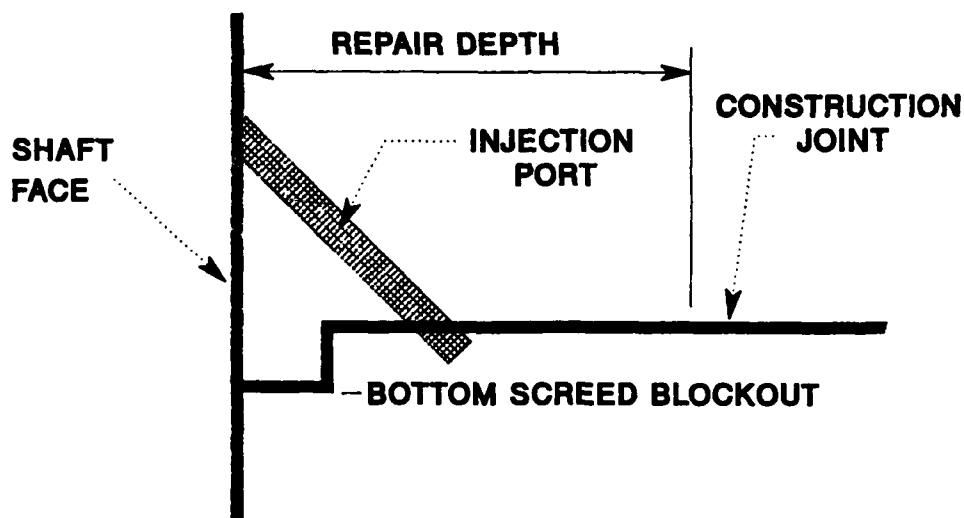
218. Only small volumes of epoxy could be injected at the horizontal ports indicating limited penetration of the epoxy into the joints. The contractor improved the penetration of the epoxy into the joints by drilling 10-in.-deep injection ports at a 45-deg incline to shaft face. These ports were located above each joint such that they intersected the horizontal portion of the joint above the assumed blockout (Figure 52).

Figure 52. Sketch of epoxy injection joint detail, Warm Springs Dam

219. After the epoxy had cured long enough to preclude its draining out from the injected voids, the pipe nipples were removed and the ports patched with Waterplug. The ports and sealed surfaces were then ground flush with the adjacent concrete surfaces.
